Regular Selectboard Meeting  
21 August 2023  
6:00 PM  
Town Office at Isle La Motte School and via Zoom

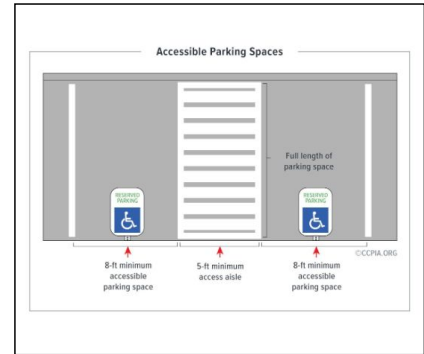
| Page 30 Item: 1 | Driveway, Walkway, Flatwork Condition | <p>1.6. The parking lot lighting was sub-standard in comparison to similar parking lots and usage.</p> <p>1.7. The parking lot was missing directional markings designed to indicate the proper flow of traffic. Directional markings should be installed at proper locations to facilitate the safe flow of traffic.</p> |

| | | <p>1.8. In the parking lot, pedestrian crosswalks were not marked. For safety reasons, all pedestrian crosswalks should be marked to comply with applicable regulations or best practice.</p> <p>1.9. Lines and arrows marked on the parking lot pavement surface were severely worn or illegible in areas and should be remarked.</p> <p>1.10. Parking stalls were not designated. Parking spaces should be marked to comply with applicable regulations or best practice.</p> <p>1.11. Total parking spaces of up to 25 requires at least one handicapped space. The handicapped parking spaces must be located on the closest and shortest route from the parking lot to the entrance of the building entrance. If there is not one building entrance, then the handicapped spaces should be located closest to the pedestrian entrance. If your building has multiple entrances, the handicapped spaces should be equal to the entrances to the building. Recommend adding handicap parking as needed or necessary.</p> |

No established parking spaces    Substandard parking lot lighting

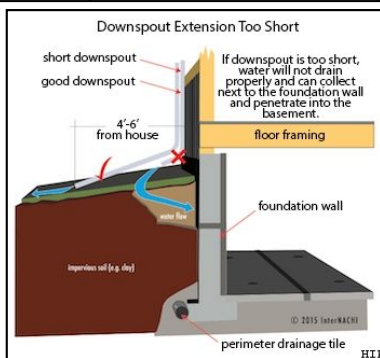
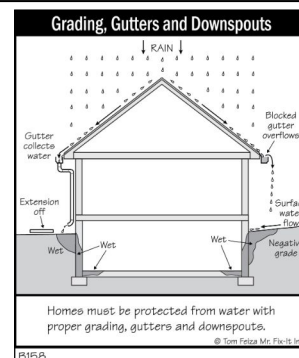
| <p>Page 42 Item: 3</p> | <p>Gutter</p> | <p>3.4. No <b>gutters</b> or downspouts. Full installation recommended to keep water away from structure. Water can weaken the foundation and deteriorate the siding. Be sure to install splashblocks or extensions to carry water away, and keep water from areas such as driveways or walks where it can be an ice hazard in winter.</p> <p>3.5. Make sure all downspouts are connected and routed to discharge away from the homes foundation (3-6 feet), this will reduce the potential for water to seep into the basement.</p> <p>3.6. Maintenance Tip: Keep gutters cleared of organic debris to prevent downspouts from being clogged causing overflow at gutters, ensure that all downspouts have extensions/splash blocks to carry water away from the foundation and ensure that sprinkler system does not spray siding or windows of house.</p> |

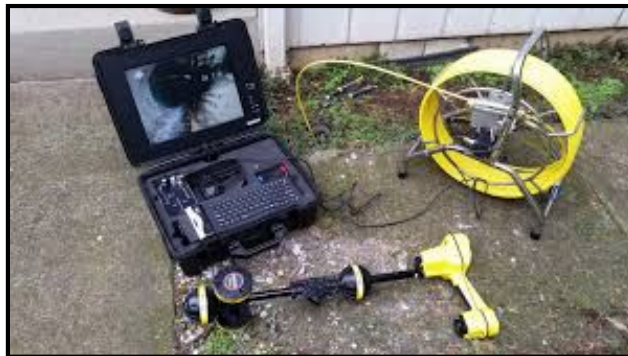
| | | <p>septic system, these inspection should be performed by a company who specializes in septic tanks and installation. We also recommend that the tank be pumped prior to the purchase of the home and every 2 to 4 years depending on the number of individuals residing in the home. For more information regarding septic systems please see: For illustrations of systems please see:<br/> <a href="http://www.environmentalenhancements.com/systems.h">http://www.environmentalenhancements.com/systems.h</a></p> <p><b>RECOMMEND THAT THE SYSTEM BE PUMPED AND CHECKED PRIOR TO CLOSING ON THE HOME. FAILURE TO DO THIS COULD RESULT IN COSTLY SURPRISES THAT MAY INCLUDE PARTIAL OR FULL REPLACEMENT OF THE SYSTEM. THIS ASPECT OF INSPECTION SHOULD NOT BE FOREGONE.</b></p> <p>1.10. Recommend that the tank be serviced, tested and pumped by a qualified septic professional every 2-4 years (depending on the individuals residing in the home).</p> <p>1.11. Recommend adding yeast ( a tablespoon per month) or a spoiled gallon of milk once every three months into your septic system to keep a balanced ecosystem.</p> <p>1.12. Due to the age of the <b>septic system</b>, we recommend that you consider having the leach field and tank inspected with a remote camera.</p> |

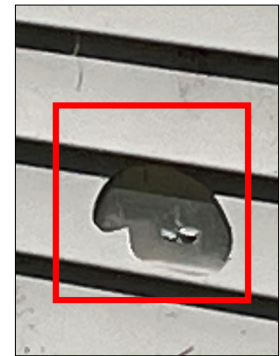
Damaged siding

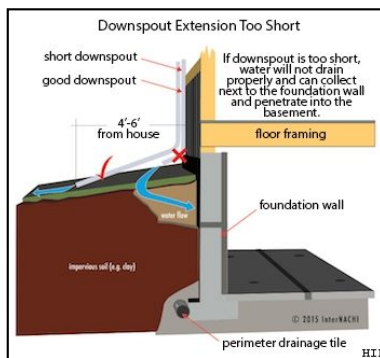
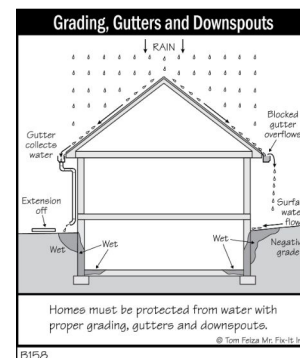
3.5. Make sure all downspouts are connected and routed to discharge away from the homes foundation (3-6 feet), this will reduce the potential for water to seep into the basement.

3.6. **Maintenance Tip:** Keep gutters cleared of organic debris to prevent downspouts from being clogged causing overflow at gutters, ensure that all downspouts have extensions/splash blocks to carry water away from the foundation and ensure that sprinkler system does not spray siding or windows of house.

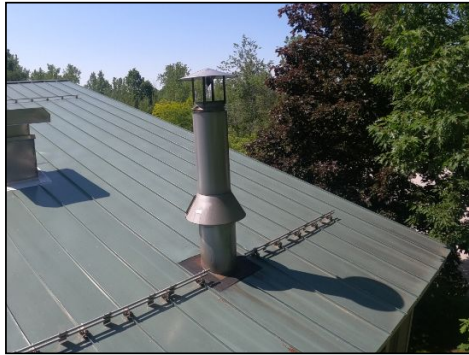
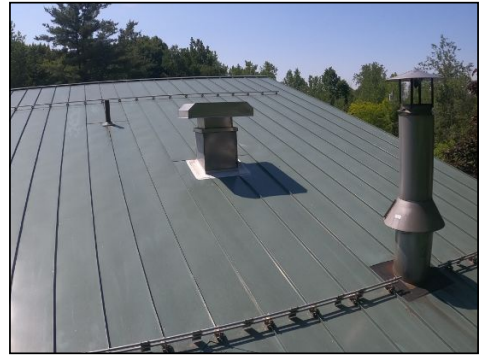
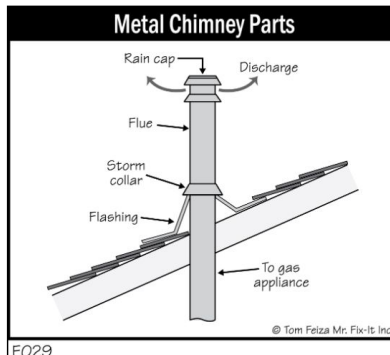
1.8. Recommend that the chimney be evaluated and cleaned prior to closing on this home and prior to each heating season by a qualified professional. Failure to do this could result in failure that could result in a house fire and secondary damage and/or costly repairs. A home inspector is not qualified to make a proper evaluation of a chimney and do not pass or fail this unit or system unless they are properly certified. You may want to contact Above the Rest Chimney Service. They can be reached at 802-888-1215.

1.9. Level 2 Chimney Inspection recommended by a qualified chimney professional.

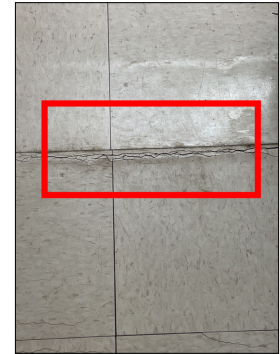
Damaged flooring noted

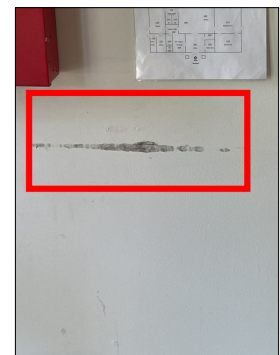
Damaged wall

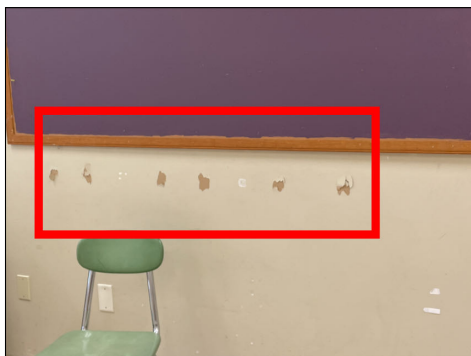
Damaged wall

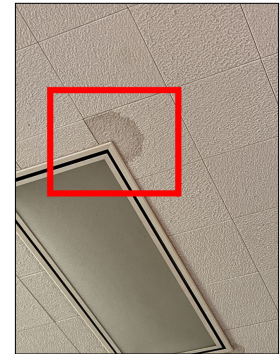
Water stains: dry

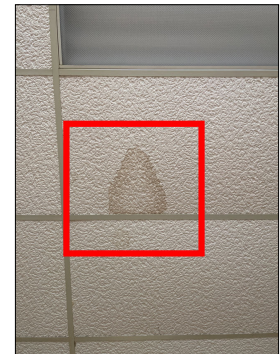
Water stains: dry

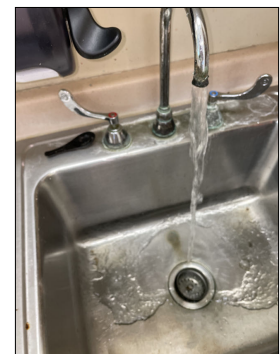
Water faucet leaking

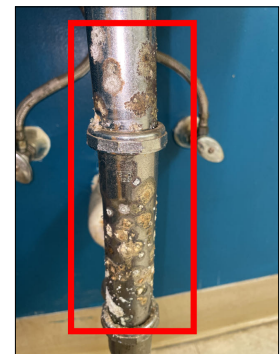
9.2. Older style metal traps noted. Buyer is cautioned that these traps can leak at any time due to corrosion.

Corrosion on pipes

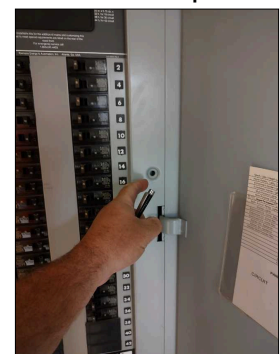
2.12. Missing panel cover screws: The dead front cover was missing screws at the time of the inspection. The Inspector recommends that appropriate screws be installed to securely attach the dead front cover.

Missing panel box screw noted
