ASSESSMENT & FINDINGS

ELEMENTARY SCHOOL

ISLE LA MOTTE

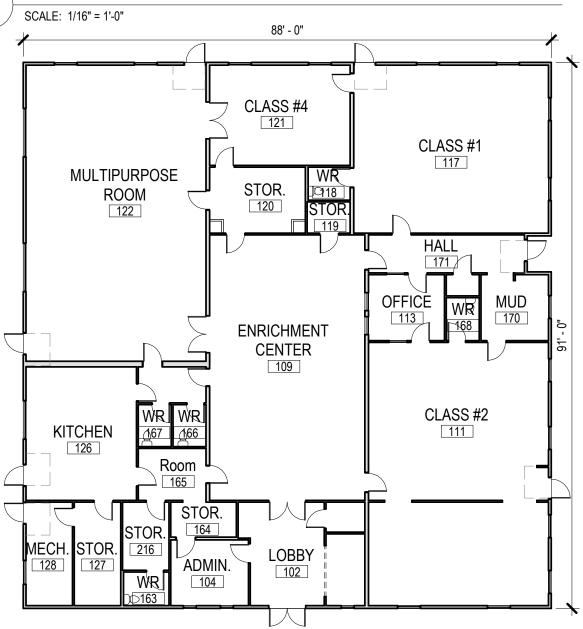
- ROOF FRAMING: PLATE CONNECTED WOOD TRUSSES AT 24" O.C. ORIGINAL DRAWINGS SHOW TRUSSES DESIGNED TO SUPPORT OWN DEAD LOAD, AS WELL AS 50 PSF SNOW LOAD
- 1ST FLOOR: CONCRETE SLAB ON GRADE WITH EDGE INSULATION (PER ORIGINAL DWGS)
- FOUNDATION: CAST-IN-PLACE CONCRETE, NO EVIDENCE OF FROST HEAVING OR SETTLEMENT

- METAL ROOFING
- VINYL SIDING AND METAL TRIM STARTING TO DEGRADE DUE TO AGE AND SUN EXPOSURE, THOUGH NO SIGNIFICANT AREAS OF DAMAGE, ROT OR SIGNS OF WATER INTRUSION WERE FOUND.
- SOME MOLD ON NORTH ELEVATION SIDING AND TRIM
- TOPOGRAPHY OF SITE DOES NOT PROVIDE FOR THE POTENTIAL TO ADD A FOOTING DRAIN, THEREFORE WATER TABLE/MOISTURE CANNOT BE ELIMINATED
- WINDOWS, DOORS APPEAR IN SERVICEABLE CONDITION

- OVERALL, THE BUILDING APPEARS IN VERY GOOD CONDITION AND SUITABLE FOR USE AS A PUBLIC BUILDING
- RE-GRADE ANY AREAS OF NEGATIVE DRAINAGE AROUND THE BUILDING
- PROVIDE AN ATTIC ACCESS HATCH FOR ON-GOING OBSERVATION AND MAINTENANCE.

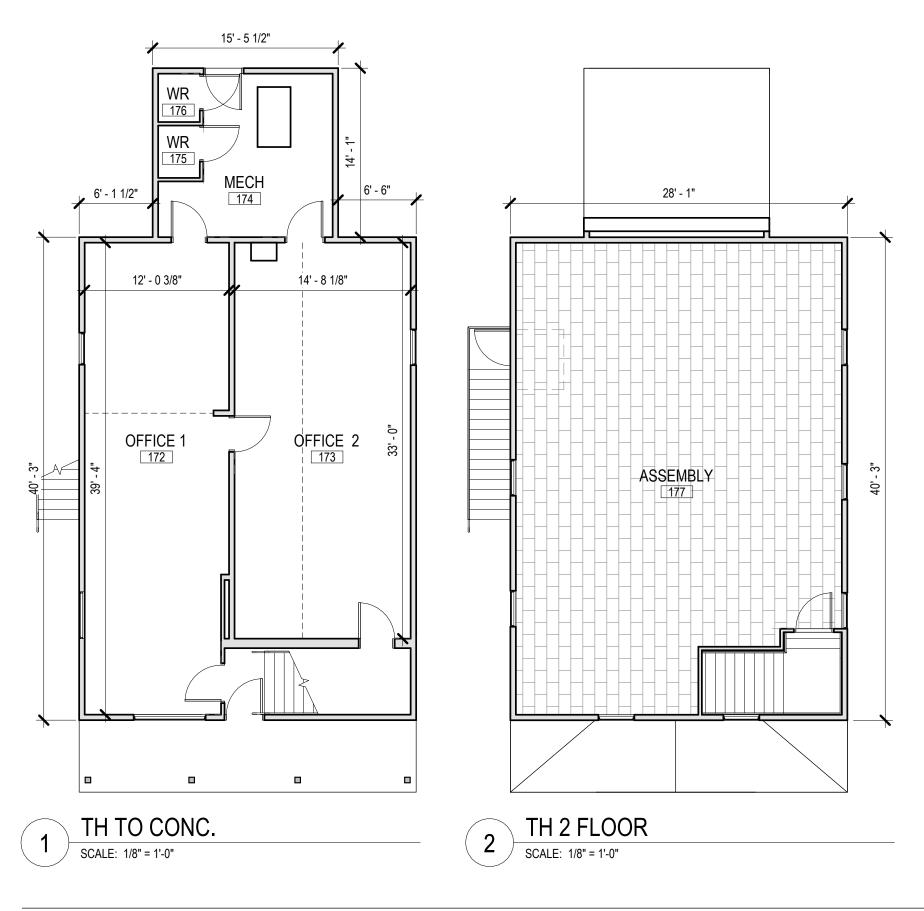
- ROOF FRAMING: 2x6 TRUSSES (1x4, 1x8 WEB)
- 2ND FLOOR FRAMING: 2x10 JOISTS AT 24" O.C.,
 - SUPPORTED BY SINGLE 5 1/2"W x 8" CENTER BEAM ON 16' O.C. COLS
- 1ST FLOOR: CONCRETE SLAB ON GRADE WITH POSSIBLE WOOD FRAMING BURIED IN THE SLAB
- FOUNDATION: DRY-LAID FIELD STONE REACHING APPROX. 22" BELOW GRADE. USDA SOIL MAPS SHOW SILTY SOILS WITH WATER TABLE 18"-36" BELOW GRADE

- METAL ROOFING
- WOOD TRIM AND CLAPBOARDS ARE IN POOR CONDITION, REQUIRING AT A MIN DEEP PREP AND RE-PAINTING, SOME REPLACEMENT
- SOME AREAS OF SIDING NEAR GRADE SHOW MOLD AND ROT
- WOOD FRAMING IS CLOSE TO GRADE. SPLASH BACK FROM ROOF RUNOFF AND MOISTURE FROM CAPILLARY ACTION HAVE CREATED CONDITIONS SUSCEPTIBLE TO ROT.
- TOPOGRAPHY OF SITE DOES NOT PROVIDE FOR THE POTENTIAL TO ADD A FOOTING DRAIN, THEREFORE WATER TABLE/MOISTURE CANNOT BE ELIMINATED

- FOUNDATION: IN ORDER TO PROVIDE MOISTURE AND THERMAL ENVELOPE SUITABLE FOR LONG-TERM USE OF THE BUILDING, A NEW FOUNDATION SHOULD BE CONSIDERED FOUNDATION REPLACEMENT OPTION:
 - JACK BUILDING AND LIFT TO ALLOW ACCESS
 - REMOVE AND REPLACE EXISTING FOUNDATION
 - REMOVE AND REPLACE (OR BUILD OVER) THE EXISTING FLOOR SLAB
 - REPLACE/REPAIR SILLS
 - REGRADE AROUND THE BUILDING TO PROVIDE POSITIVE DRAINAGAE AWAY
 - PLACE BUILDING BACK ON NEW FOUNDATION IDEALLY SLIGHTLY ELEVATED
- 2ND FLOOR FRAMING:
 - EXISTING JOISTS ARE SUITABLE FOR ASSEMBLY, OFFICE OCCUPANCIES
 - REINFORCE OR REDUCE SPAN OF MID-SPAN BEAM
- ROOF FRAMING:
 - EXISTING CAN BE LEFT AS-IS IN SHORT TERM. IF INSULATION ADDED TO ATTIC OR IF ROOFING IS TO CHANGE, RAFTERS SHOULD BE REINFORCED.
