Property Inspection Report

42 School St Ext Isle La Motte VT 05463

Year Built: 1998

Date of Inspection: 6/21/2023

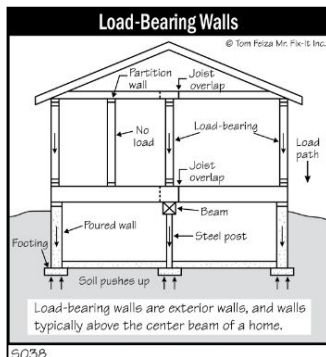
7.11. Wall damage noted. Repair as needed or necessary.

Damaged wall

For more about repairing walls, please visit the following video link: <https://www.youtube.com/watch?v=qbupCzSPW9o>

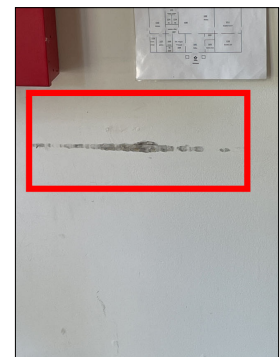
Damaged wall

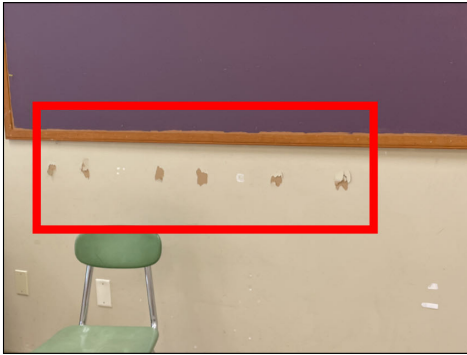
Damaged wall

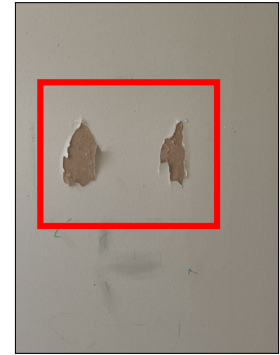
Damaged wall

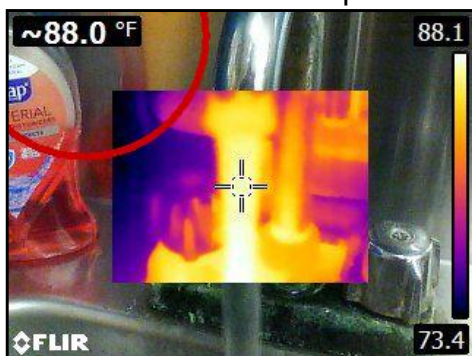
1.3. The hot water temperature at the time of inspection was: 88 degrees.

Hot water temperature
