Regular Selectboard Meeting  
21 August 2023  
6:00 PM  
Town Office at Isle La Motte School and via Zoom

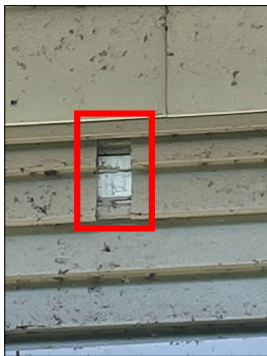
| <p>Page 35 Item: 1</p> | <p>Siding Condition</p> | <p>1.9. <b>Loose siding</b> noted . Recommend securing the siding as needed or necessary.</p> <p>1.10. Siding damage noted. Recommend repair or replacement as needed or necessary.</p> <p>1.11. Peeling paint observed.</p> <p>1.12. Gaps in vinyl siding noted where moisture can enter. Recommend repairing as needed or necessary.</p> |

Gaps in vinyl siding

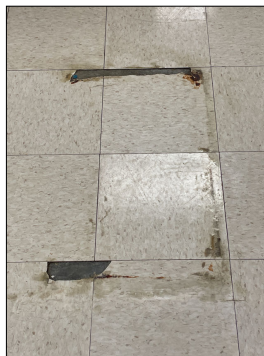
| Page 58 Item: 6 | Floor Condition | <p>6.3. Damaged floor noted. Recommend review for repair or replacement by a qualified professional as needed or necessary.</p> <p>6.4. The floor appeared to be affected by high levels of moisture. This would happen through vapor diffusion and capillary suction with moisture coming to the <b>concrete</b> from below. Recommend trying to manage moisture off the roof areas with gutters, while moving moisture away from the building.</p> |

Damaged flooring noted

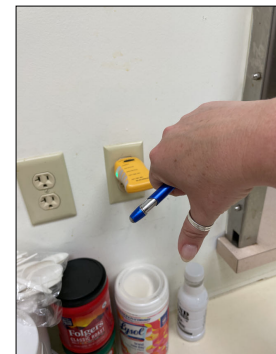
3.4. No **GFCI** protection present, suggest installing GFCI protected receptacles for safety.( areas of the kitchen). From International Residential Code: Section E3902. E390 2.6 Kitchen receptacles: " 125-volt, single phase, 15 and 20 ampere receptacles that serve countertop surfaces shall have ground fault circuit interrupter protection for personnel."

Receptacle that needs to be GFCI protected

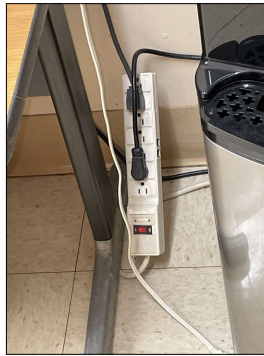
3.5. Extension cords shall not be used as a substitute for permanent wiring. All extension cords shall be removed and/or replaced with adequately placed electrical outlets installed by a licensed electrician. If wiring new electrical outlets this work requires an electrical permit from the Division of Fire Safety and must be obtained BEFORE work may commence.NFPA 11.1.5.3.5 Extension cords and flexible cords shall not be affixed to structures, extend through walls, ceilings, floors, or under doors or floor coverings or be subject to environmental or physical damage. 1:11.1.7.6

Extension cord being used for permanent power

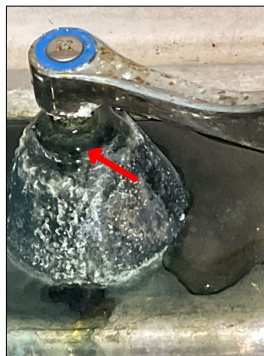
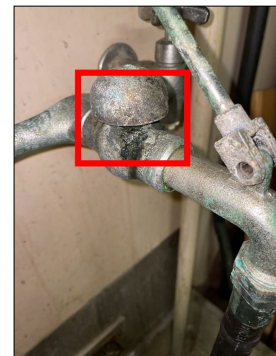
4.4. Faucet leaks at base. Recommend repairing as needed or necessary.

Water faucet leaking at the base

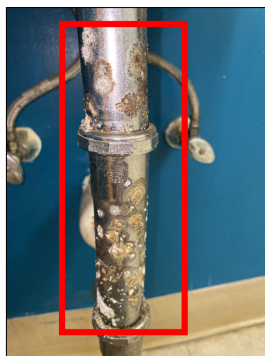
9.2. Older style metal traps noted. Buyer is cautioned that these traps can leak at any time due to corrosion.

Corrosion on pipes

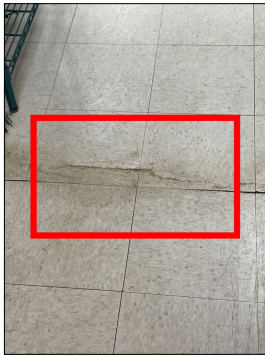
17.2. Damaged floor noted. Recommend review for repair or replacement by a qualified professional as needed or necessary.

Damaged flooring noted

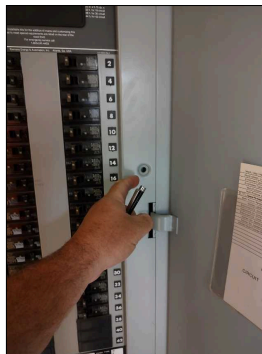
| Page 80 Item: 2 | Electrical Panel | 2.12. Missing panel cover screws: The dead front cover was missing screws at the time of the inspection. The Inspector recommends that appropriate screws be installed to securely attach the dead front cover. |

Missing panel box screw noted

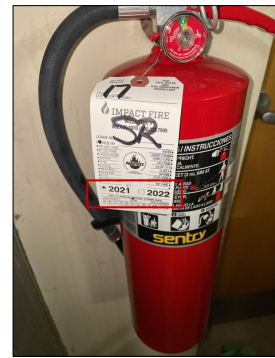
| <p>Page 106 Item: 1</p> | <p>Condition/Location</p> | <p>1.19. Fire extinguisher noted as not being properly tagged, inspected. NFPA 1:13.6.3.1.14: Portable Fire Extinguishers</p> <p>One properly sized fire extinguisher shall be provided and shall be mounted properly and inspected annually. The fire extinguisher shall be inspected and tagged by a technically qualified person(s) or be replaced with a new extinguisher, annually.</p> <p>1.20. ---<b>Electrical room</b>---<b>Lighting and electricity</b></p> <p>1.21. GFCI protection needed: See grounds, garage, foundation, kitchen, bathroom, shed</p> |

Fire extinguisher not properly tagged

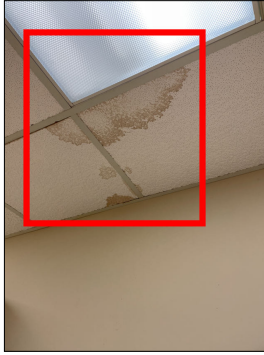
17.2. Evidence of past leaking was noted. Areas were dry at the time of inspection.

Evidence of past moisture damage noted

17.3. Damaged areas of ceiling noted. Recommend repairing as needed or necessary.

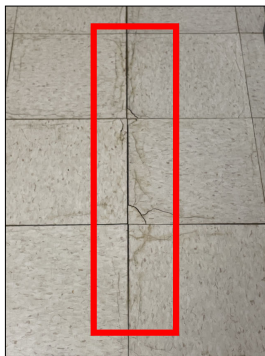
Damaged flooring noted

6.3. Damaged floor noted. Recommend review for repair or replacement by a qualified professional as needed or necessary.

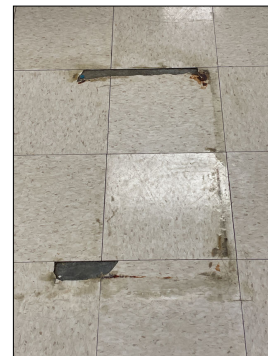
Damaged flooring noted

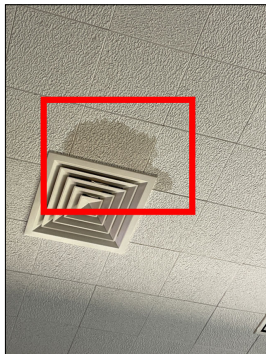
Water stains: dry

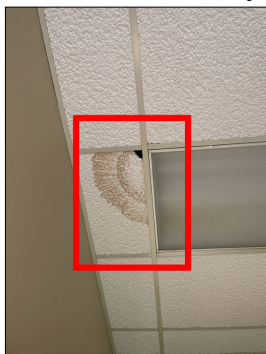
Water stains: dry

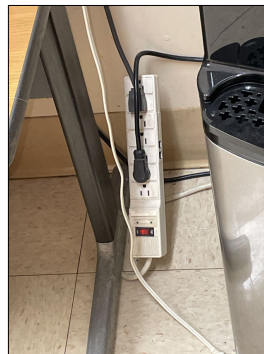
Extension cord being used for permanent power

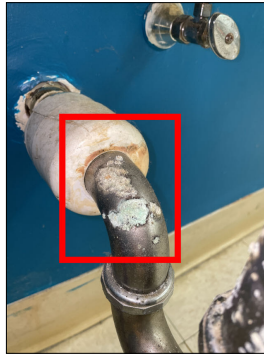
9.2. Older style metal traps noted. Buyer is cautioned that these traps can leak at any time due to corrosion.

Corrosion on pipes

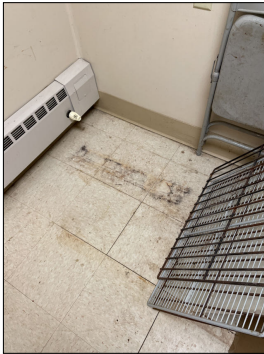
17.2. Damaged floor noted. Recommend review for repair or replacement by a qualified professional as needed or necessary.

Damaged flooring noted

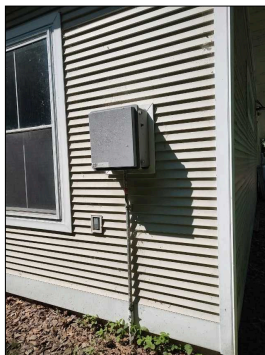
Septic tank alarm

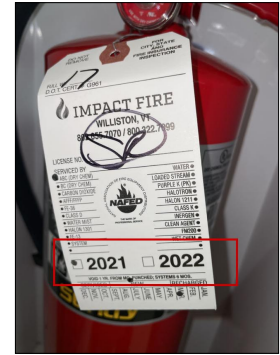
1.19. Fire extinguisher noted as not being properly tagged, inspected. NFPA 1:13.6.3.1.14: Portable Fire Extinguishers

Fire extinguisher not properly tagged

One properly sized fire extinguisher shall be provided and shall be mounted properly and inspected annually. The fire extinguisher shall be inspected and tagged by a technically qualified person(s) or be replaced with a new extinguisher, annually.
