ASSESSMENT & FINDINGS

ELEMENTARY SCHOOL

ISLE LA MOTTE

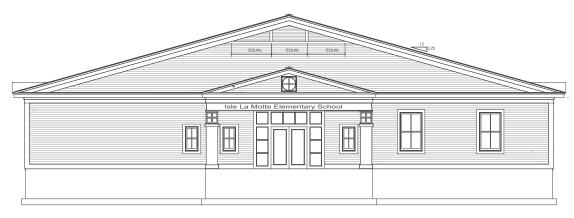
🚺 Ēxist. Elevations WEST

- ROOF FRAMING: PLATE CONNECTED WOOD TRUSSES AT 24" O.C. ORIGINAL DRAWINGS SHOW TRUSSES DESIGNED TO SUPPORT OWN DEAD LOAD, AS WELL AS 50 PSF SNOW LOAD
- 1ST FLOOR: CONCRETE SLAB ON GRADE WITH EDGE INSULATION (PER ORIGINAL DWGS)
- FOUNDATION: CAST-IN-PLACE CONCRETE, NO EVIDENCE OF FROST HEAVING OR SETTLEMENT

- METAL ROOFING
- VINYL SIDING AND METAL TRIM STARTING TO DEGRADE DUE TO AGE AND SUN EXPOSURE, THOUGH NO SIGNIFICANT AREAS OF DAMAGE, ROT OR SIGNS OF WATER INTRUSION WERE FOUND.
- SOME MOLD ON NORTH ELEVATION SIDING AND TRIM
- TOPOGRAPHY OF SITE DOES NOT PROVIDE FOR THE POTENTIAL TO ADD A FOOTING DRAIN, THEREFORE WATER TABLE/MOISTURE CANNOT BE ELIMINATED
- WINDOWS, DOORS APPEAR IN SERVICEABLE CONDITION

- OVERALL, THE BUILDING APPEARS IN VERY GOOD CONDITION AND SUITABLE FOR USE AS A PUBLIC BUILDING
- RE-GRADE ANY AREAS OF NEGATIVE DRAINAGE AROUND THE BUILDING
- PROVIDE AN ATTIC ACCESS HATCH FOR ON-GOING OBSERVATION AND MAINTENANCE.
