Regular Selectboard Meeting  
21 August 2023  
6:00 PM  
Town Office at Isle La Motte School and via Zoom

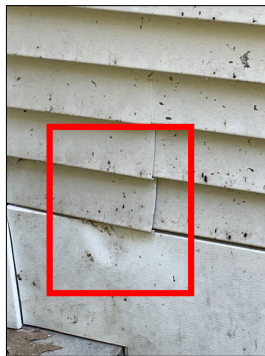
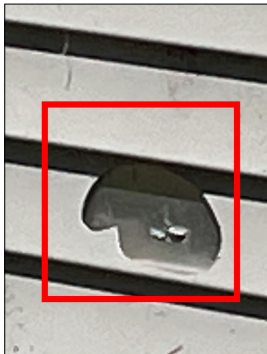
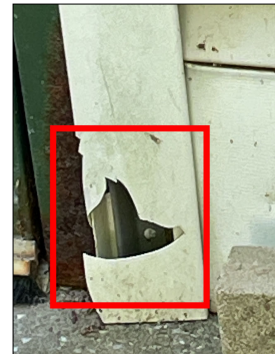
| <p>Page 35 Item: 1</p> | <p>Siding Condition</p> | <p>1.9. <b>Loose siding</b> noted . Recommend securing the siding as needed or necessary.</p> <p>1.10. Siding damage noted. Recommend repair or replacement as needed or necessary.</p> <p>1.11. Peeling paint observed.</p> <p>1.12. Gaps in vinyl siding noted where moisture can enter. Recommend repairing as needed or necessary.</p> |

Damaged siding

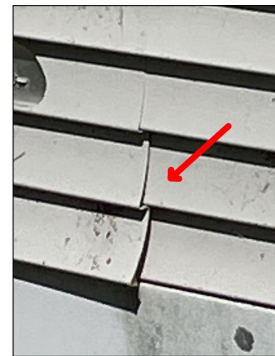
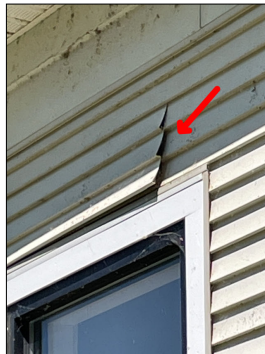
Loose siding

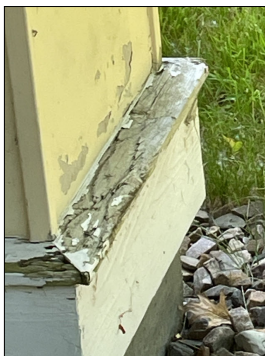
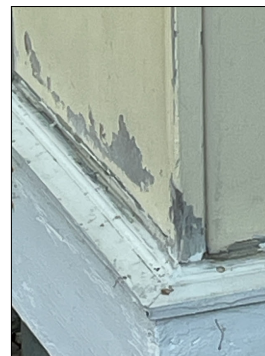
2.4. Peeling paint observed, suggest scraping and painting as necessary.

Peeling paint

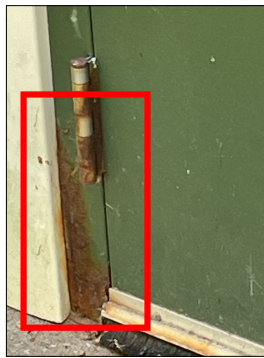
4.1. Damaged exterior door(s) noted. Recommend review for repair or replacement as needed or necessary.

Damaged door

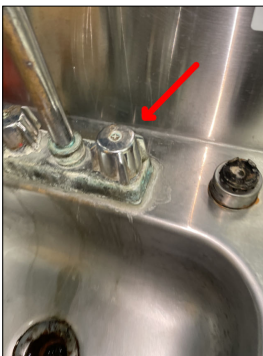
No water from cold side of faucet

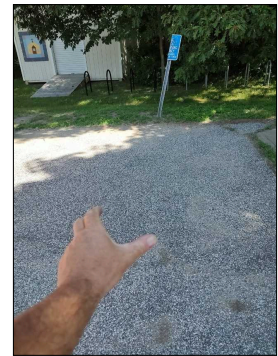
1.11. Total parking spaces of up to 25 requires at least one handicapped space. The handicapped parking spaces must be located on the closest and shortest route from the parking lot to the entrance of the building entrance. If there is not one building entrance, then the handicapped spaces should be located closest to the pedestrian entrance. If your building has multiple entrances, the handicapped spaces should be equal to the entrances to the building. Recommend adding handicap parking as needed or necessary.

No handicap parking markings

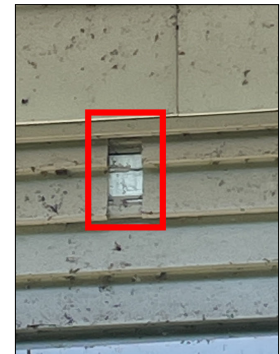
1.12. Gaps in vinyl siding noted where moisture can enter. Recommend repairing as needed or necessary.

Gaps in vinyl siding

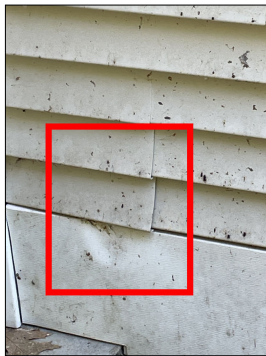
1.10. Siding damage noted. Recommend repair or replacement as needed or necessary.

Damaged siding

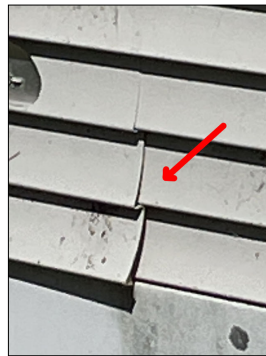
1.9. **Loose siding** noted . Recommend securing the siding as needed or necessary.

Loose siding

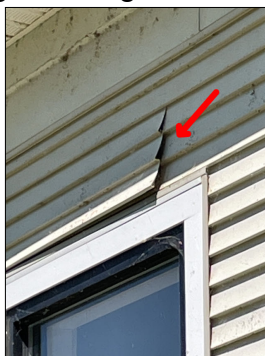
Loose siding

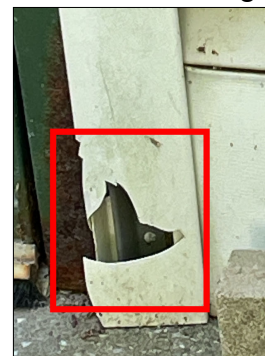
Damaged siding

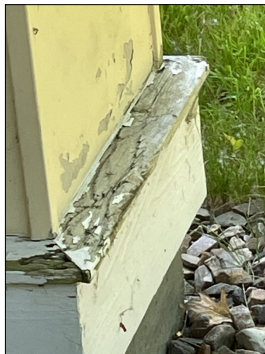
1.11. Peeling paint observed.

Peeling paint

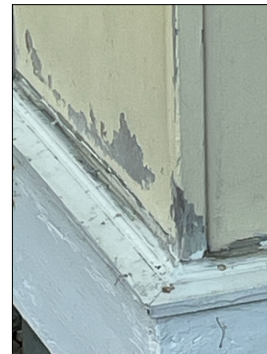
Peeling paint

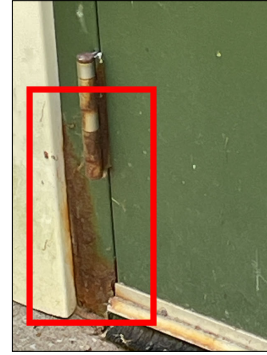
4.1. Damaged exterior door(s) noted. Recommend review for repair or replacement as needed or necessary.

Damaged door

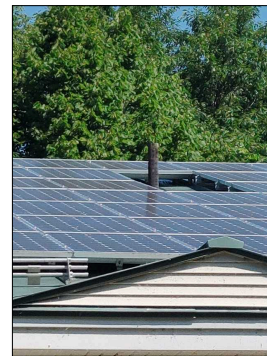
### 2.2. **PVC** vent pipe noted

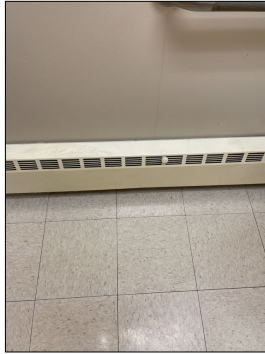
14.2. Baseboard hot water heat noted

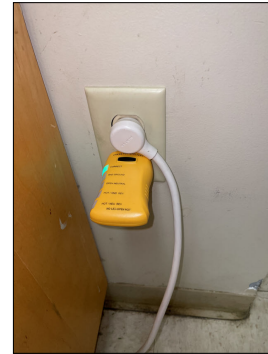
Testing receptacles

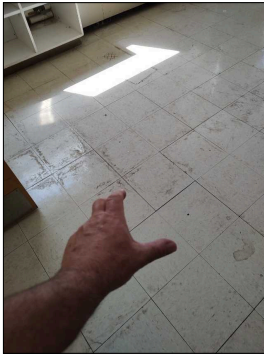
6.4. The floor appeared to be affected by high levels of moisture. This would happen through vapor diffusion and capillary suction with moisture coming to the concrete from below. Recommend trying to manage moisture off the roof areas with gutters, while moving moisture away from the building.

Evidence of vapor diffusion and capillary action: moisture affecting the flooring

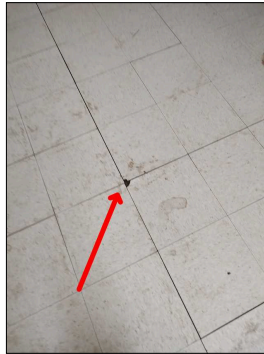
6.3. Damaged floor noted. Recommend review for repair or replacement by a qualified professional as needed or necessary.

Damaged floor

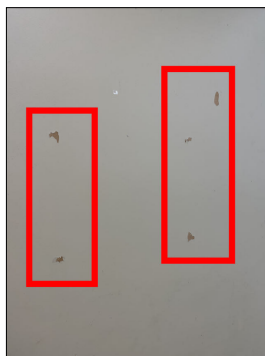
Damaged wall

7.11. Wall damage noted. Repair as needed or necessary.

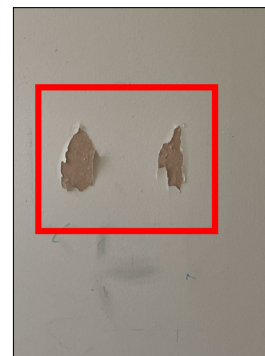
Damaged wall

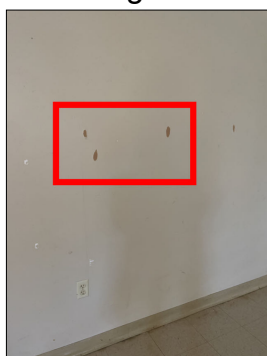
Damaged wall

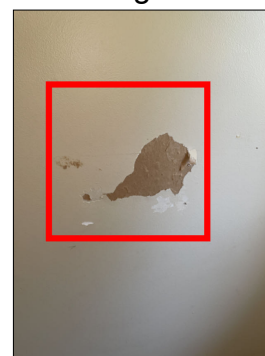
Damaged wall

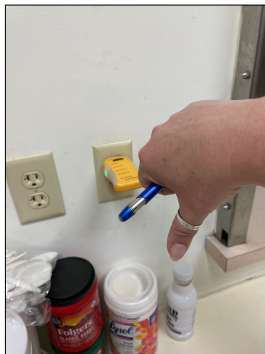
Receptacle that needs to be GFCI protected

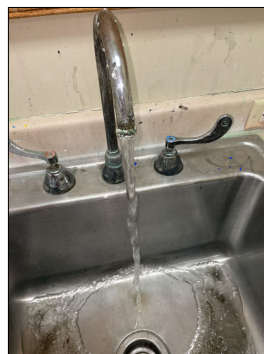
No water from cold side of faucet

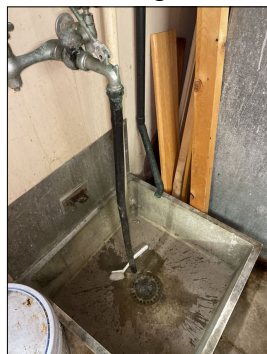
Water faucet leaking

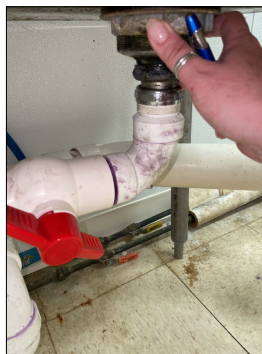
9.2. Older style metal traps noted. Buyer is cautioned that these traps can leak at any time due to corrosion.

Corrosion on pipes

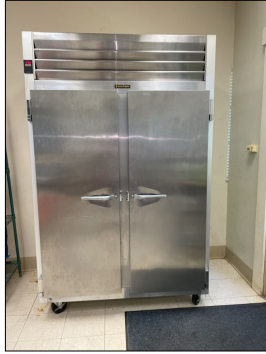
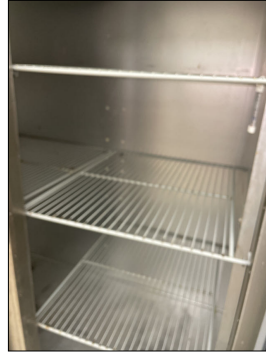
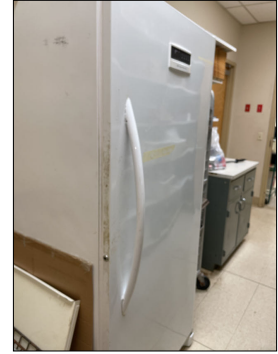
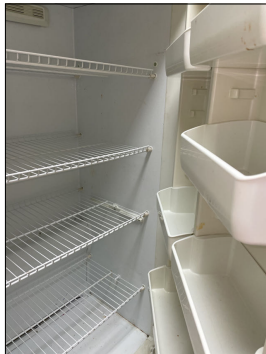
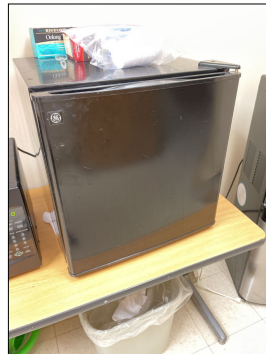
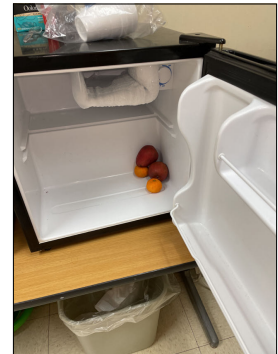
Refrigerator operating

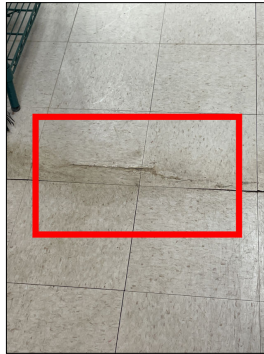
17.2. Damaged floor noted. Recommend review for repair or replacement by a qualified professional as needed or necessary.

Damaged flooring noted

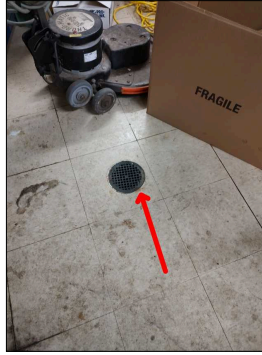
Floor drain

Condition: Verify function in case of an Emergency - Recommend testing the functionality of the basement floor drain. This can be done with a standard garden hose. It is important that this drain is tested and functional in case of a plumbing or foundation leak. If it is not functioning as designed it is better to find out under a controlled test than when it is seriously needed.

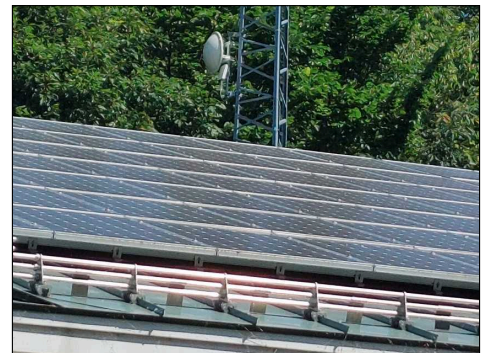
2.9. The home had a grid-tied photovoltaic (PV) system installed. A PV system is a system that converts sunlight to electricity. A grid-tied system is one that is connected to the power company electricity supply system. When the PV system is producing electricity, it causes the electric meter (called a "net meter") to spin backwards. This can reduce monthly electrical costs or even generate income.

Photovoltaic panels

You will need to learn about the system maintenance and operation requirements. This system requires a specialist inspection, and not all electrical contractors will be qualified. The Inspector strongly recommends that you have the PV system inspected before the expiration of your Inspection Objection Deadline. These systems commonly produce enough electricity to cause serious or fatal injury. You should have good

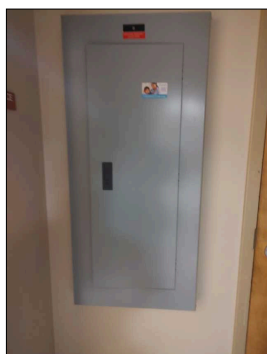
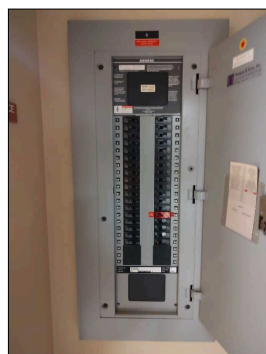
2.12. Missing panel cover screws: The dead front cover was missing screws at the time of the inspection. The Inspector recommends that appropriate screws be installed to securely attach the dead front cover.

Missing panel box screw noted

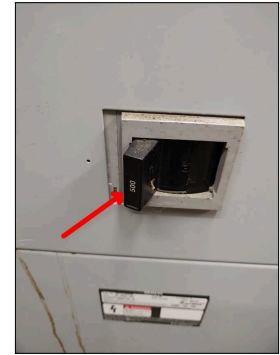
3.2. 500 amp: The pictured electrical service disconnect will shut off all power to the home in the case of an emergency, or for servicing.

500 amp service

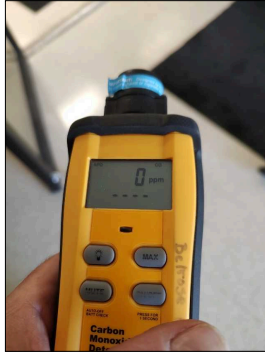
1.7. Carbon monoxide levels in the home are measured during inspection. The following levels were noted: 0

Level of carbon monoxide in the home: 0

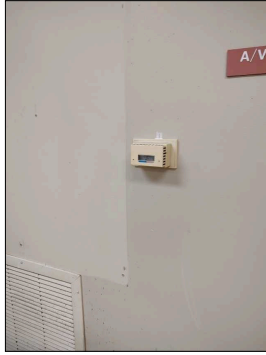
Thermostat location

7.6. Analog, non-programmable type.

7.7. Electric heat thermostats noted in each room

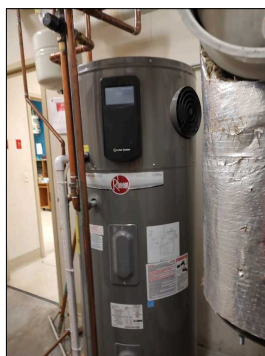
- Hybrid hot water heater with a drop in heat pump noted
- Rheem
- Manufacture date: 2016

Age of hot water heater: 2016

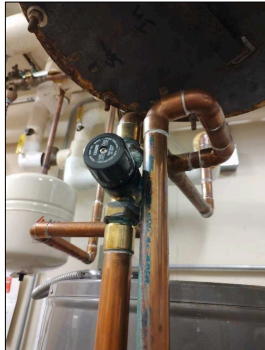
3.3. Thermostatic Mixing valve noted as in place and operating

Thermostatic mixing valve for the hot water heater

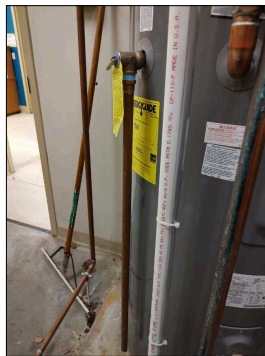
4.2. The water heater discharge pipe should be cut any 45 degree angle at the bottom.

Vermont code: 504.6 (15) Outlet of all relief valve piping shall be cut on a 45 degree angle.

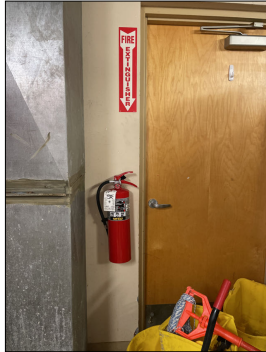
1.19. Fire extinguisher noted as not being properly tagged, inspected. NFPA 1:13.6.3.1.14: Portable Fire Extinguishers

Fire extinguisher not properly tagged

One properly sized fire extinguisher shall be provided and shall be mounted properly and inspected annually. The fire extinguisher shall be inspected and tagged by a technically qualified person(s) or be replaced with a new extinguisher, annually.
